State of New Hampshire
DEPARTMENT OF ENVIRONMENTAL SERVICES

LETTER OF DEFICIENCY
WMB-BWQ-2003-01
August 14, 2003

Re: File #1049, Chalk Pond, Newbury, Lot 67.

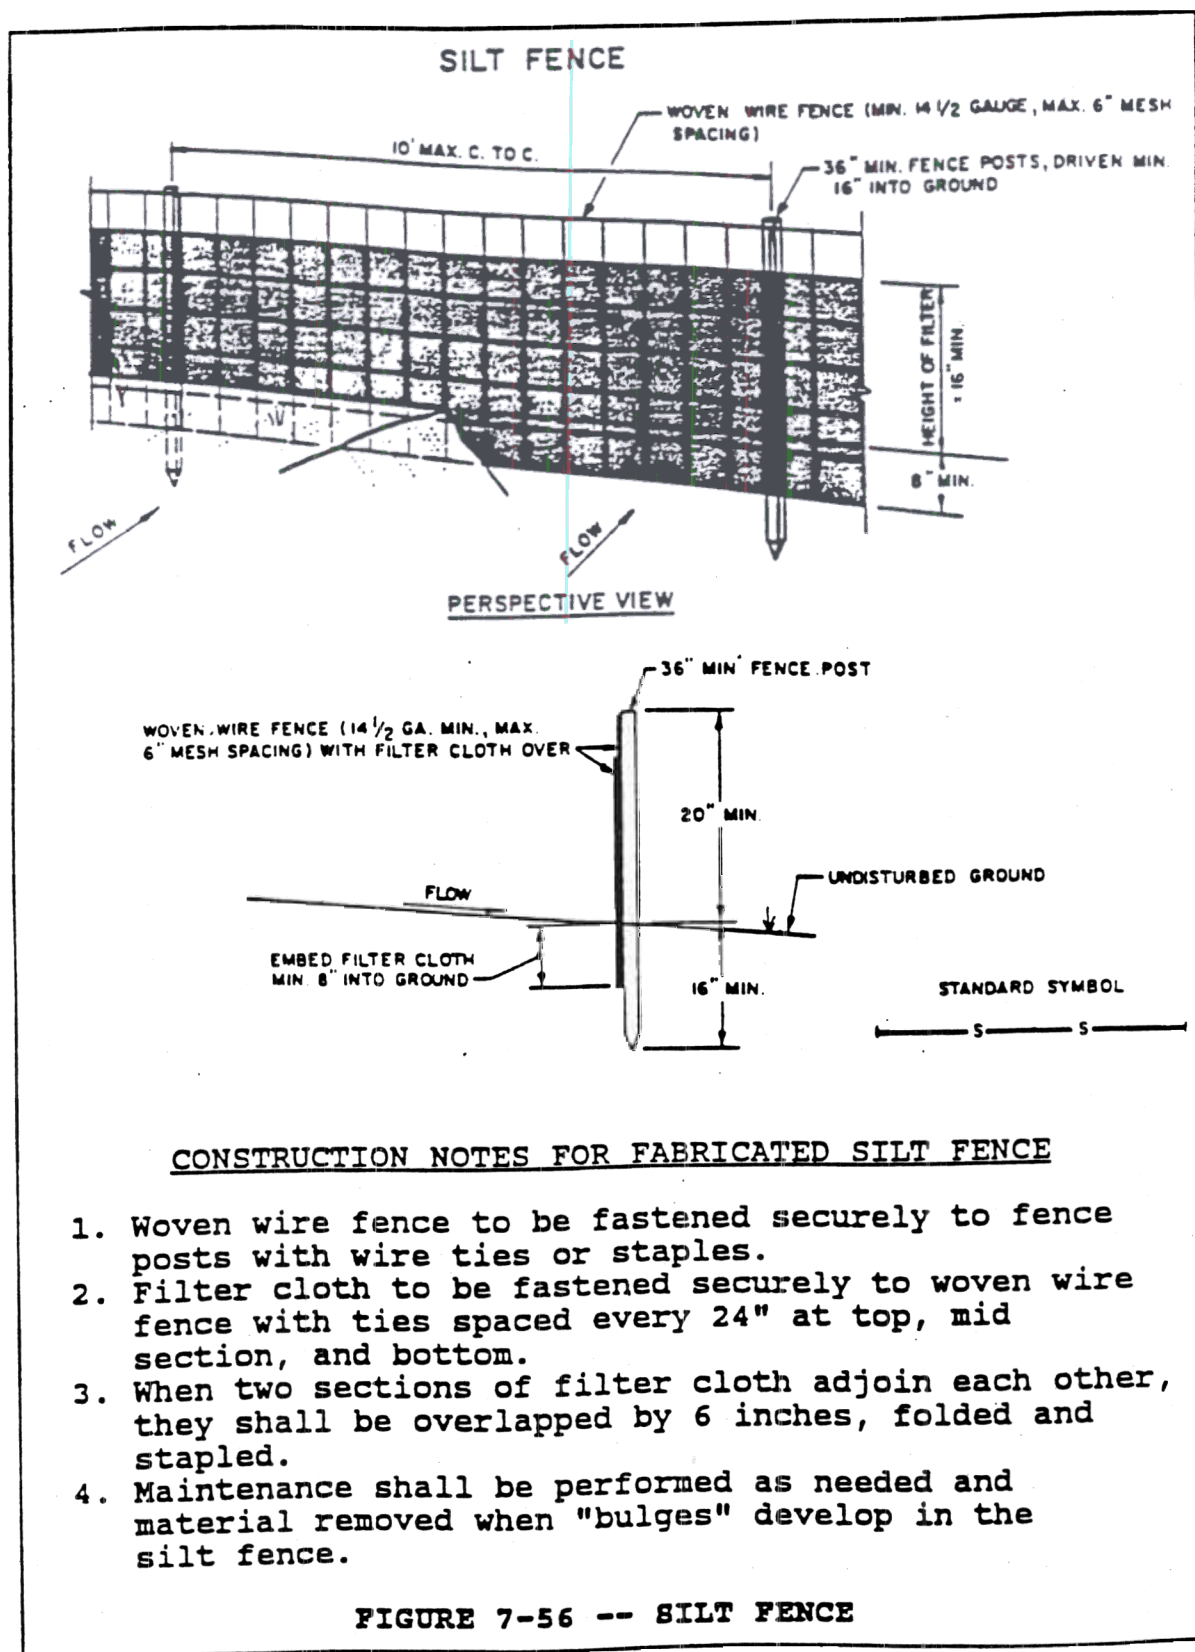
Source: USDA Soil Conservation Service

Enclosed, for your information, are details of proper silt fence and hay bale intallation. If you have any questions, please contact Andy Chapman at (603) 271-5334 or achapman@des.state.nh.us.
